Town of Dillon

Conditions Survey

Town of Dillon, Colorado

*Surveyed in September / October 2008
Report Submitted October 2008*

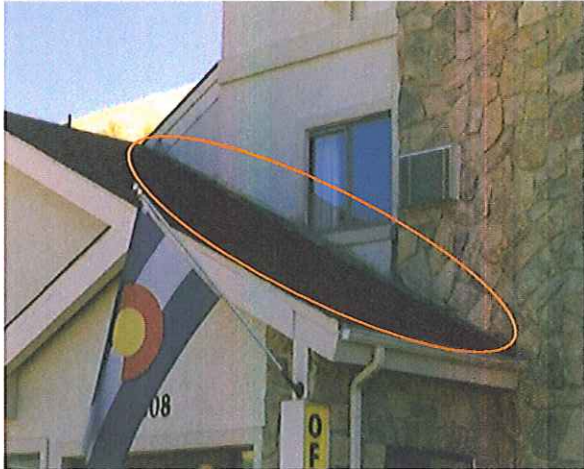
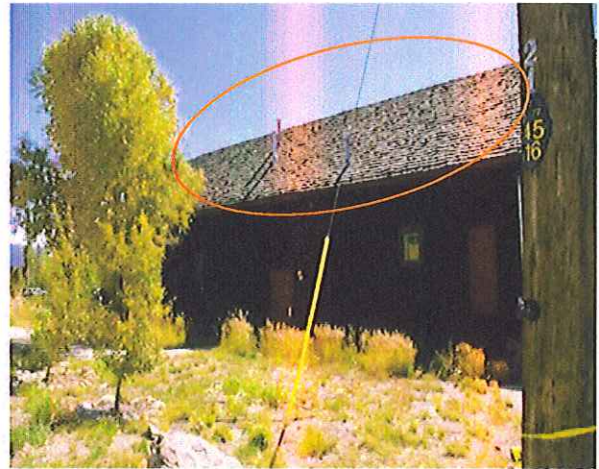
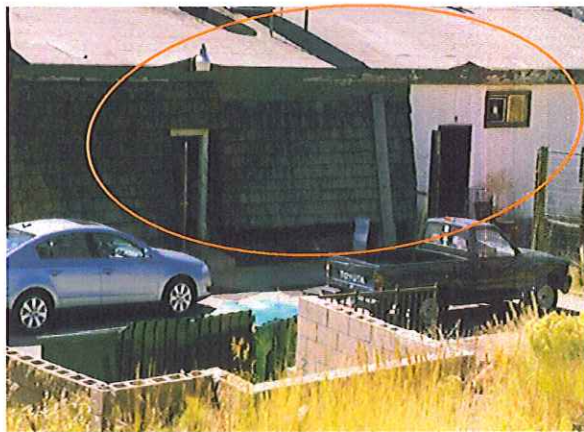
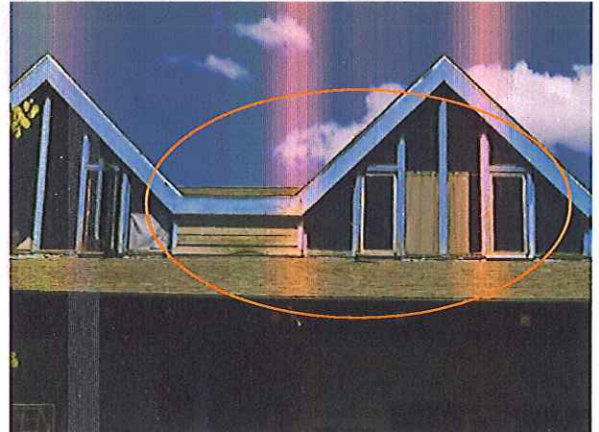
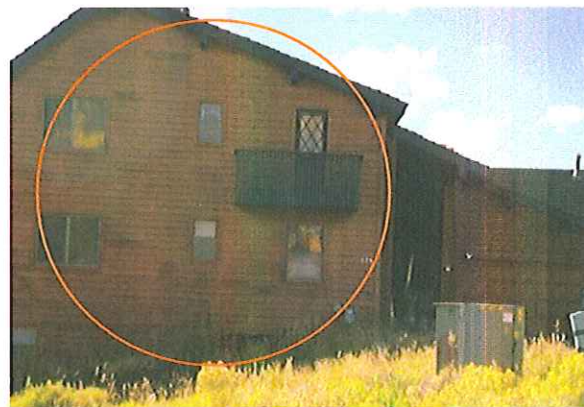
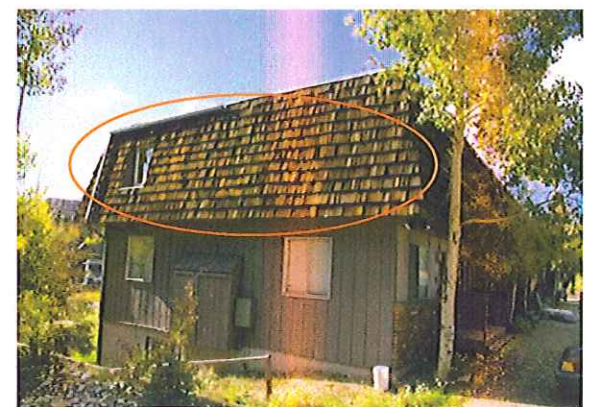
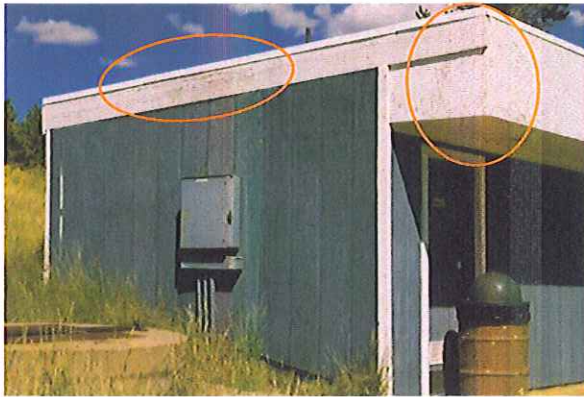
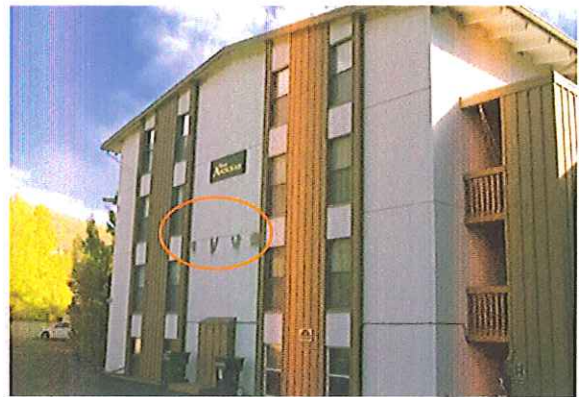
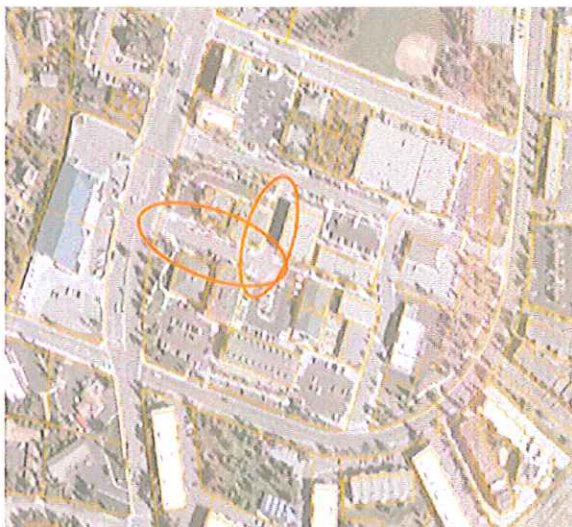
The condition of structures in the Study Area is generally good, but a number of buildings exhibit signs of deterioration, particularly in roof materials, exterior surfaces and fascia/trim/flashing. A few properties had dilapidated fencing (including one town park/open space facility).

Examples of Condition (a) Slum, Deteriorated and Deteriorating Structures:

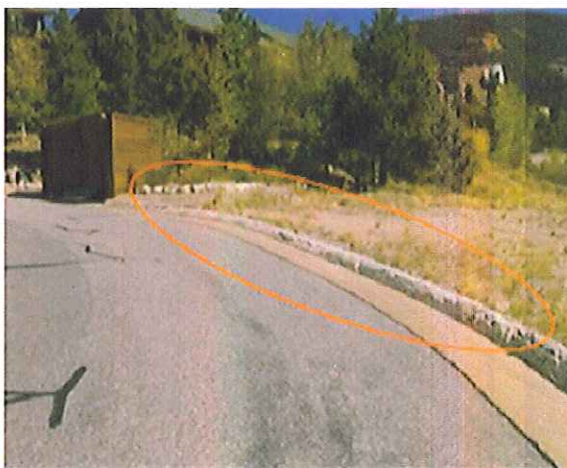
The “L” intersection of Schroeder Avenue and Village Place, in the heart of Town Center, exacerbates the already poor vehicular flow pattern in that area. Another example of inadequate vehicular access and poor street layout is evidenced by the extensive curb damage found within the Lookout Ridge development – suggesting that a lack of flow options requires frequent U-turns for residents and visitors. Businesses behind the Conoco station and historic Lake Dillon Theater are not easily accessible by public roads. By standards of other, similarly-sized retail developments, vehicular access to the entire Dillon Ridge area is indirect and inconvenient for shoppers.

Dual cul-de-sac formed by Schroeder Avenue and Village Place exacerbates the awkward circulation in the Town Center.

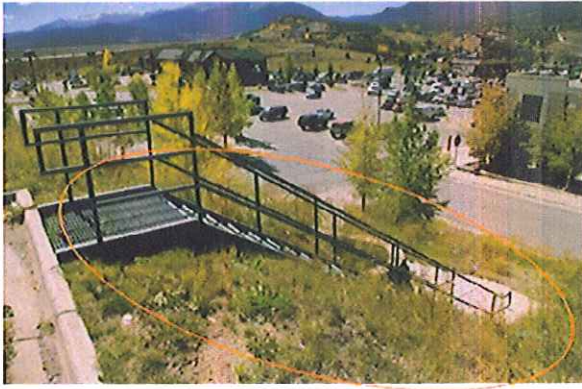
Dangerous slope for a business operating after dark

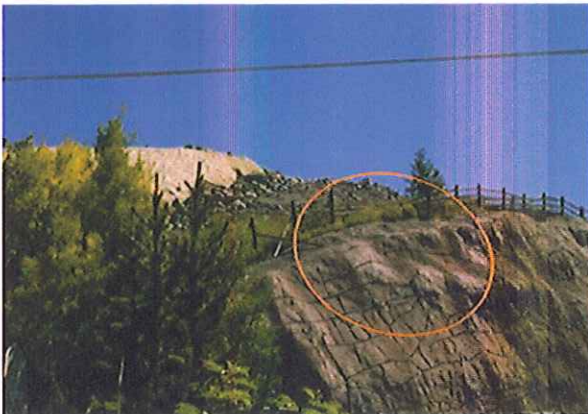
Steep slopes and dilapidated fencing

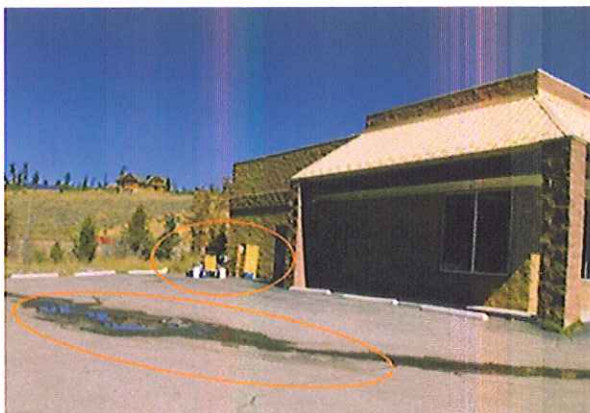
Unlit; exposed paint / chemicals; drainage issues

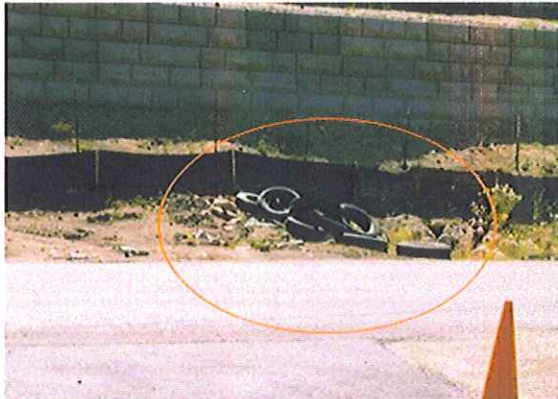
Rubble, weeds, open dumpster

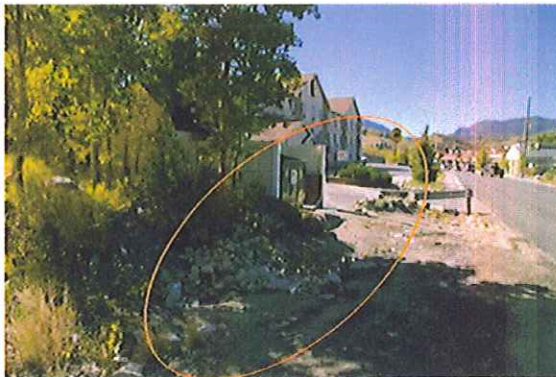
Trash, weeds, neglect

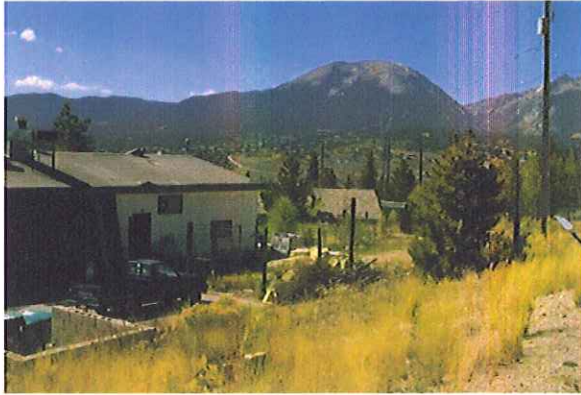
Examples of Condition (f) Unusual Topography or Inadequate Public Improvements

As a mountain community, Dillon has numerous examples of unusual topography due to steep slopes. Inadequate public improvements can be found throughout Dillon particularly in areas with overhead utilities (which, contrary to many typical small towns, has underground utilities in the Town Center, but not in certain residential areas). Street and curb damage, though uncommon, is another type of inadequate public improvement found in the Study Area. Water infrastructure in the Town Center area is considered inadequate due to insufficient peak water flow for fighting a major fire. The Town Center area also has limited excess electrical capacity for public uses such as additional lighting and power for special events.
