Subject: Comments Regarding Slope Stability  
Dillon Ridge Vistas  
Block 6, Dillon Ridge Marketplace  
Summit County, Colorado  
Project No. SU01304-125

As requested, we conducted a slope stability analysis of the proposed grading plan at the subject site. We previously provided a Preliminary Geotechnical Investigation at the site (see report dated January 27, 2017, Project No. SU01304-125). This letter should serve as a supplement to that report. Proposed construction includes three buildings with 12 units each (36 units total). Each building will be a three-story, wood-frame structure. An asphalt parking lot with concrete curb and gutter will be provided. Overlot grading will include cut depths of around 16 feet below existing grade.

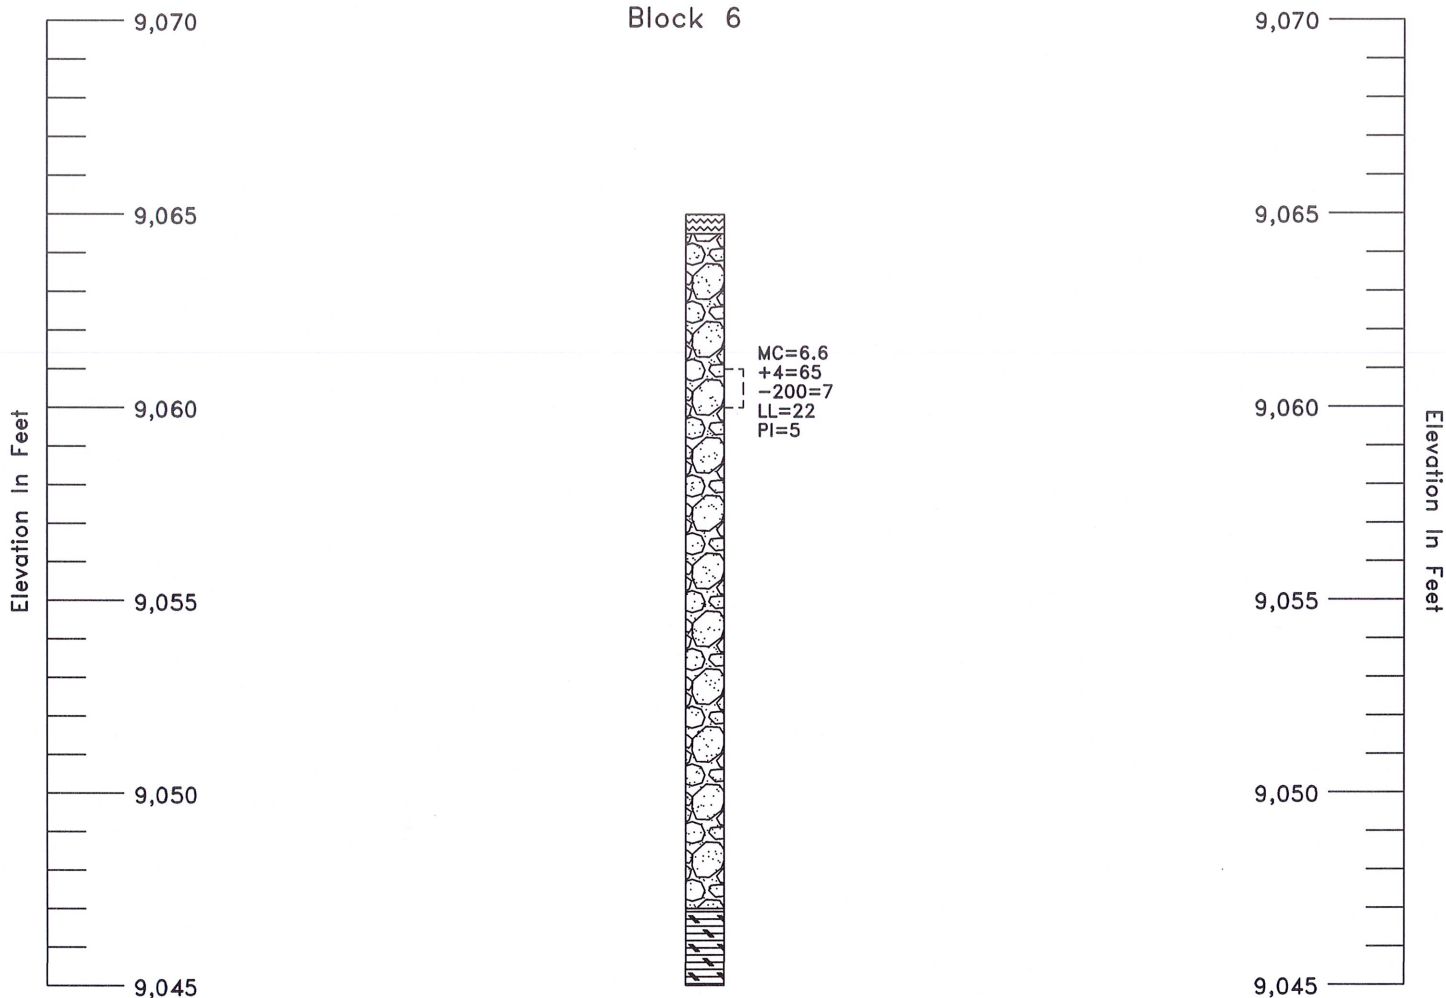
TP-10  
 ELEV.=9,065  
 Block 6

TOPSOIL; silty, sandy, with roots, moist, dark brown (OL)

GRAVEL; silty to slightly clayey, sandy with subrounded to subangular cobbles up to 10 inches in diameter, medium dense, moist, medium brown. (GP-GC, GM)

SHALE BEDROCK; very weathered, fractured fissile, mostly flat surface, very moist, orange brown. Strike 82 degrees, Dip 44 degrees.

1. This pit was excavated with a Caterpillar 336E on May 4, 2017.
2. No free water was observed in the pit at the time of excavation. The pit was backfilled. Groundwater levels can fluctuate. Iron staining in pit indicates seasonal water seepage.
3. Pit location as shown on Figure 2 was measured from site features and should be considered approximate.
4. Pit elevation was estimated from topography shown on Figure 1 and should be considered approximate. Elevation was checked by instrument level.
5. These exploratory pits are subject to the explanations, limitations and conclusions contained in our January 27, 2017 report.

We conducted subsurface exploration at the site for our previous report. Three test pits (TP-1, TP-2 and TP-3) were excavated on Block 6. The conditions encountered in the test pits generally consisted of fill soils overlying weathered shale bedrock. In TP-1, clayey, sandy gravel was found above the weathered shale. In TP-2 and TP-3, a layer of sandy clay was encountered above the weathered shale. The thickness of the clay layer ranged from 6 to 24 inches. A full description of the conditions encountered in TP-1, TP-2 and TP-3 and laboratory test results are shown in our January 2017 report. In order to conduct our slope stability analysis, we observed an additional test pit on the site (TP-10) at the location shown on Figure 1. Conditions encountered consisted of slightly clayey to silty, sandy gravel with cobbles to a depth of 18 feet. Gradation and classification testing was conducted on a sample of the gravel soils, see Figure 3. Weathered shale was found below the gravel to the depth explored of 20 feet. No clay was encountered in TP-10. Bedding planes of the shale dip across and against the hillside. No free water was encountered; however, the iron staining of the shale indicates seasonal water seepage. A graphic log of the test pit is shown on Figure 2.

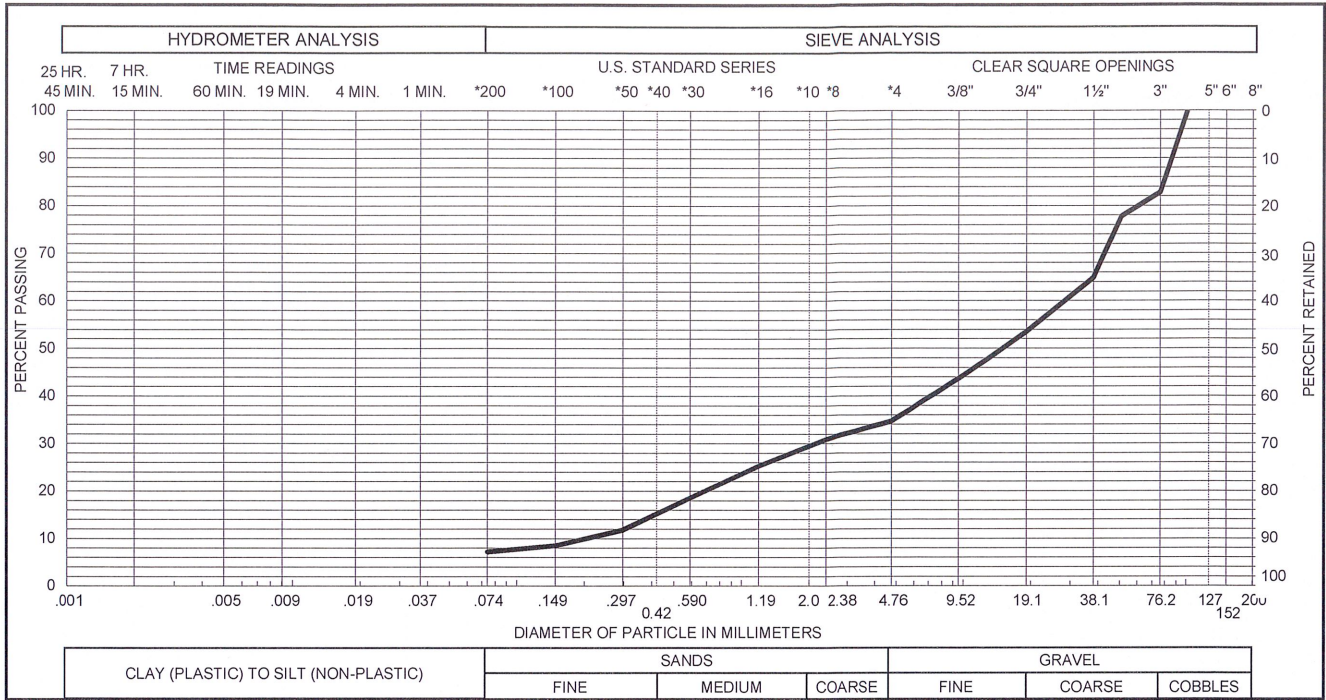
Curve No. 1

Sieve Size	% Passing
4 in.	100
3 in.	83
2 in.	78
1.5 in.	65
3/4 in.	54
1/2 in.	48
3/8 in.	44
No. 4	35
No. 8	31
No. 16	25
No. 30	19
No. 50	12
No. 100	9
No. 200	7
